ASSESSMENT OF ROCKFALL POTENTIAL OF LIMESTONE HILLS IN THE KINTA VALLEY

NORBERT SIMON^{1*}, MUHAMMAD FAHMI ABDUL GHANI¹, AZIMAH HUSSIN¹, GOH THIAN LAI¹, ABDUL GHANI RAFAEK², NORAINI SURIP³, TUAN RUSLI TUAN MONAM⁴ AND LEE KHAI ERN⁵

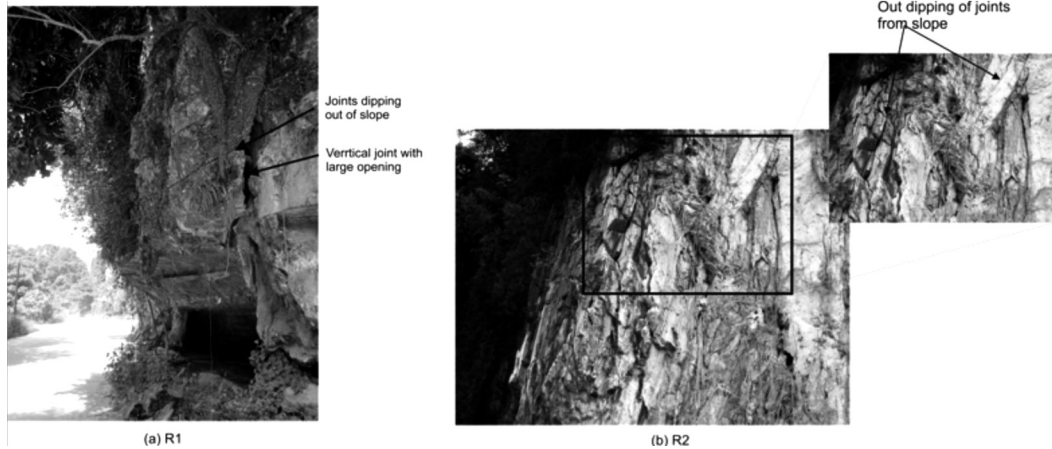
Figure 3: Very unfavourable jointings at Stations R1 and R2 result in the two stations being classified in the weak group of the RMS. (a) Vertical joints with wide opening and moderate dipping of daylighting joints (b) sub-vertical to vertical dipping of joints

The Stations R1, R2, and R3 are located at the foot slope of Gunung Rapat. These stations are easily accessible by road. Based on Table 3, Stations R1 and R2 exhibit signs of weakness in the slope such as very unfavourable dipping of joints out of the slope and visible opening of joints which are wider than 30 mm. In the RMS scheme, these observations have the lowest ratings. Both of these stations also have very low average intact rock strength (25) as indicated by the Schmidt hammer test. Intersections of joints dipping out of the slope are clearly visible in both stations and plant roots filling the gaps of the vertical joints may widen the joints' opening (Figure 3). The susceptibility of rock failure may be increased by vibrations generated from movement of heavy vehicles such as lorries that use roads close to these hills. Although the slope at Station R3 does not exhibit the same level of susceptibility as that at Stations R1 and R2, its condition cannot be taken lightly as the calculated final score is just slightly over the margin of the weak group, which is 50.

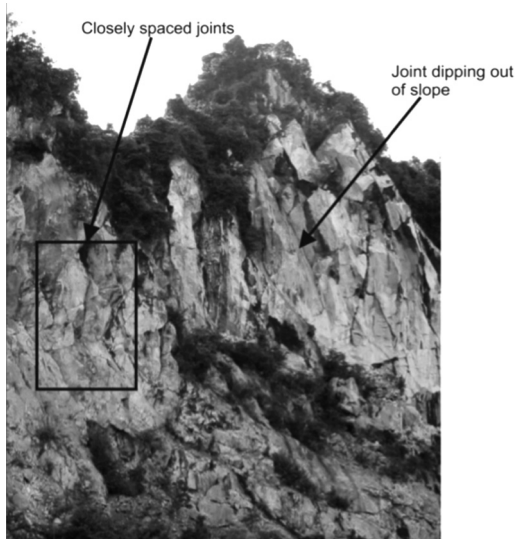
The slopes at both Stations L1 and L2 are classified as weak based on their RMS final scores. Joints on both hills were noticeably clear but joint patterns were difficult to recognise due to blasting activities (Figure 4). However, the joint spacings are closely spaced and the joints dip moderately to steeply out of the slope. In addition, the width of the joints is also wide with openings of more than 20 mm. Most of these features were observed at the foot slope.

Figure 4: The condition of the exposed rock slope at Station L2 where joints are closely spaced, dipping out of the slope and the major of orientation is difficult to be determined due to the high joints density

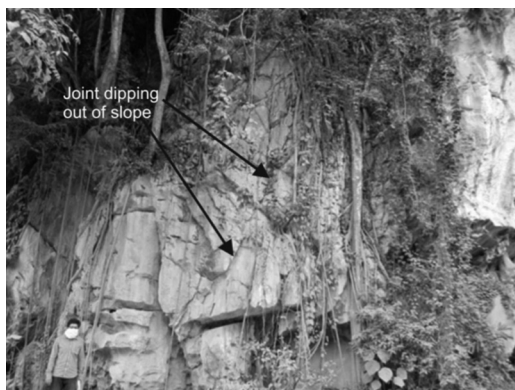
Figure 5: Joints dipping out of slope in Station Pj1 increases its susceptibility to failure

All the slopes at the assessment stations at Gunung Paniang, Gunung Kandu, Gunung Panjang and Gua Tempurung were categorised as moderate. However, it is good to note that these slopes are all in the marginal or lower part of the moderate scoring range especially for Station K1 (Gunung Kandu) and Pj1 (Gunung Panjang). These stations were found to be susceptible due to their joint orientations that are dipping moderately to steeply out of the slope. This

condition may pose great danger to passersby if rock blocks are dislodged from the slope (Figure 5). The contributing factors that put these slopes into the moderate group are that the rocks are slightly to moderately weathered, the spacings between joints are wide and the joints are either horizontal or moderately dipping.
